NUMBER: 08-002-18 REV. A

GROUP: 08 - Electrical

DATE: February 27, 2018

Radio Software Enhancements RAN RAP RAJ RAG and RSD

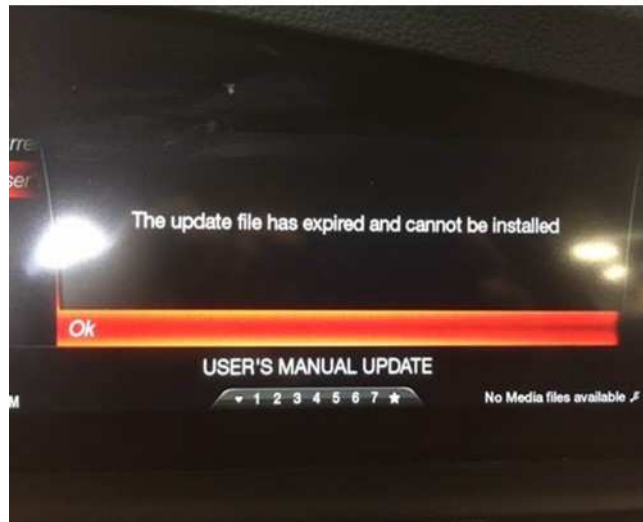
Fig. 1
Update File Error Prompt

Some technicians may experience an error when they attempt to update the User Guide. The radio may prompt an error, “The update file has expired and cannot be installed” (Fig. 1) .
